New Forest HLS Stream Restoration Works at DITCHEND, July 2014

Produced by Friends of Latchmore - 2 August 2014

Note: *This Paper provides information gathered in relation to the exceptional and unannounced Works carried out by the Forestry Commission at Ditchend in July 2014.*

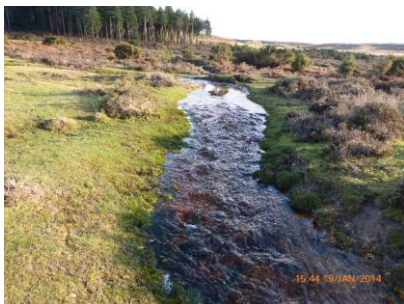
January 2014 - near Pitts Wood looking upstream

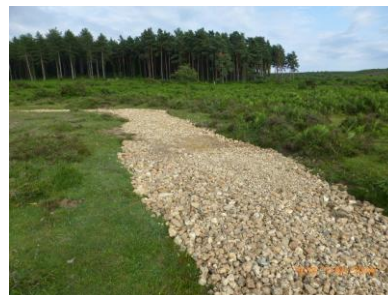
11 July 2014 - Same reach after infilling

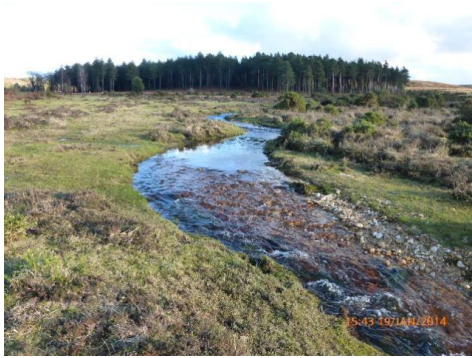
January 2014 - Looking upstream .

Why would such a reach need to be refilled only 6 months later ? Overtopping did not restrict the scouring (see the FC justification for the July 2014 infilling at para 14 below)

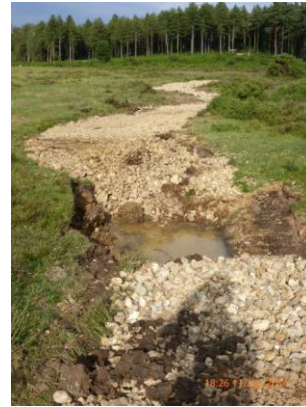
11 July 2014 - The same reach. This also shows one of the points still to be filled with a clay plug (?) which is normally used in these projects to prevent water moving down the channel ? Excavation was deeper than visible, as already partially filled with material.

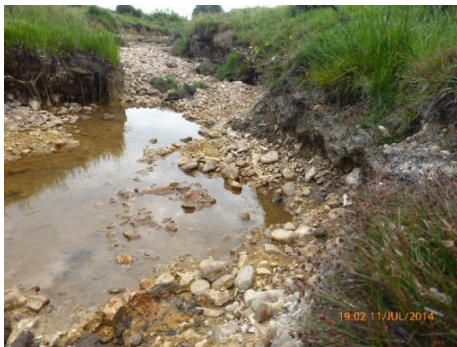
Eroded meanders created in 2011, as at January 2014 - before the current refill

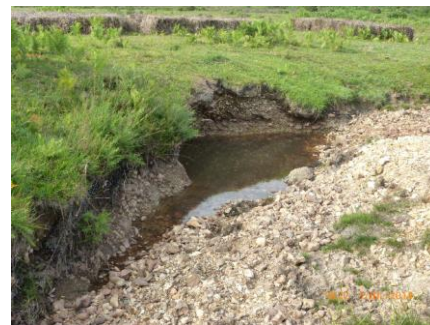
Bank undercutting and deposition which has now been buried by July 2014 works

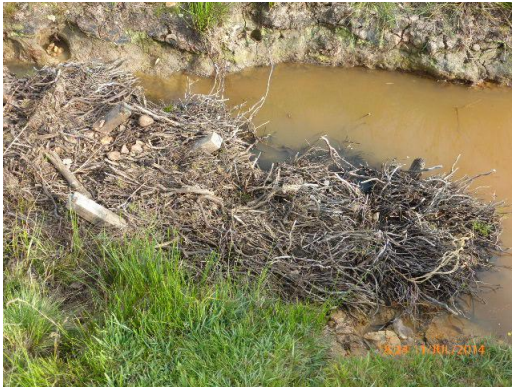
Stakes holding heather bales, still visible from 2011 works

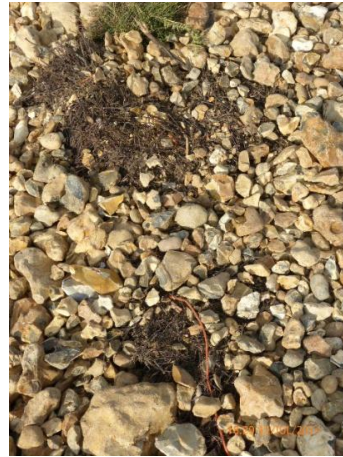
Exposed heather and string visible after July 2014 works

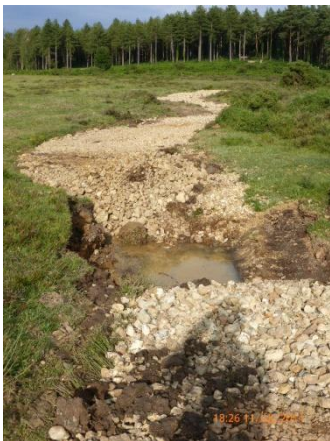
Site ready for clay plug (?) - 11 July 2014

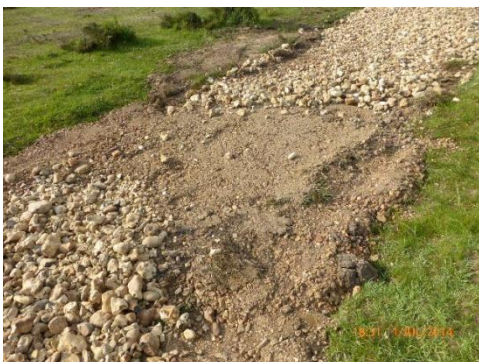
Change of surface material after July 2014 works. Possible site of clay plug ?

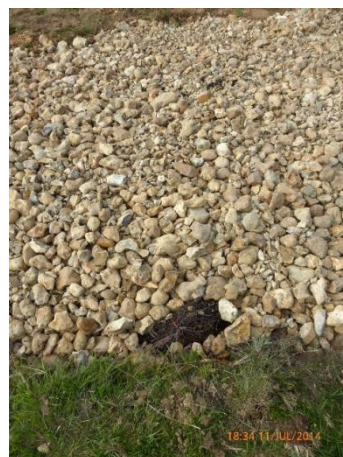
Exposed heather bales and string after July 2014 works

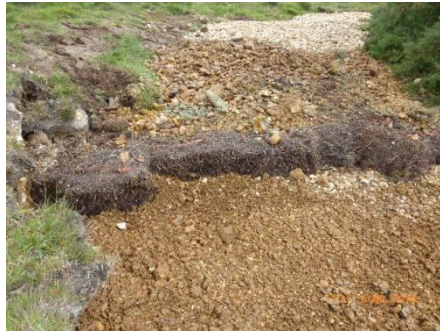
The layers including unwashed hoggin, heather bales, hoggin, and large stones visible during the works - 16 July 2014.

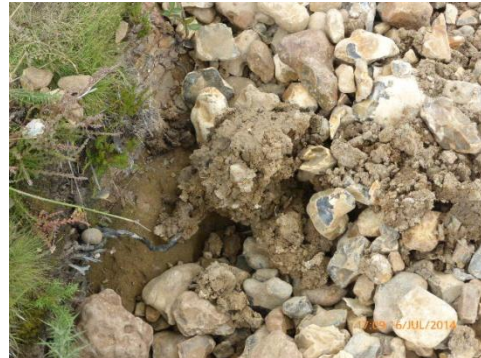
...and a ball of clay in an exposed bank edge

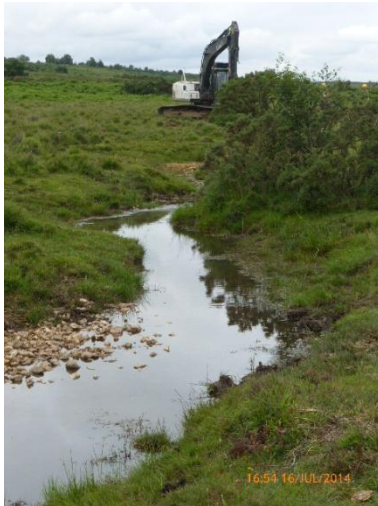
16 July 2014, before infill looking upstream.

Part of Section 4, Ditchend stream as created in 2011, after 3 years "use" .

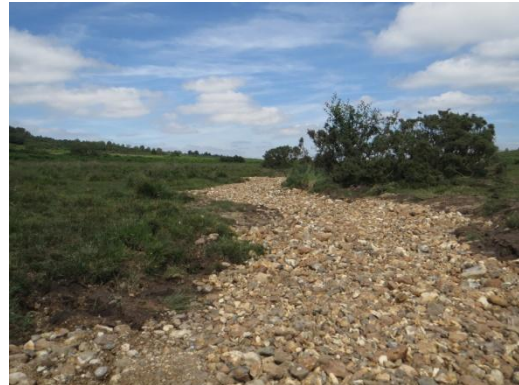
Same reach as filled in 18 July 2014

Hoggin, heather bales , and gravel have been built up to a level which covers the previous bank edges.

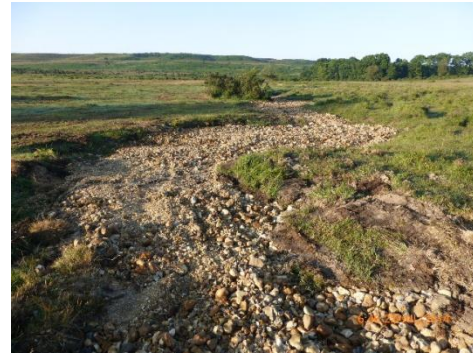
22 July 2014 - after the current works. Significant infill of far bank; right foreground (of 16 July photo) infilled and some vegetation and clay (from where ?) added.

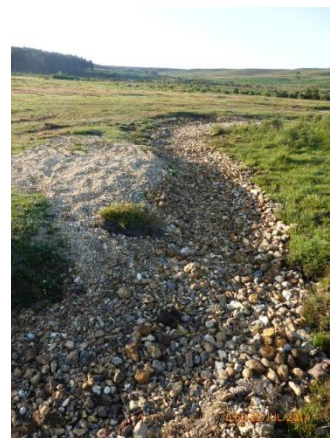
22 July 2014 - infilled to top of bank

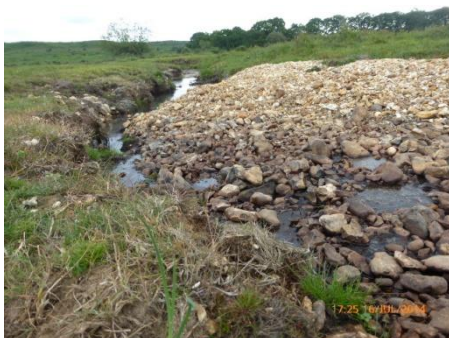
16 July 2014 - Looking downstream towards fallen willow. Why has this significant amount of gravel been deposited here from the creation of the 2011 channel ? Probably because the 2011 channel was not compatible with the flood flows that have occurred.

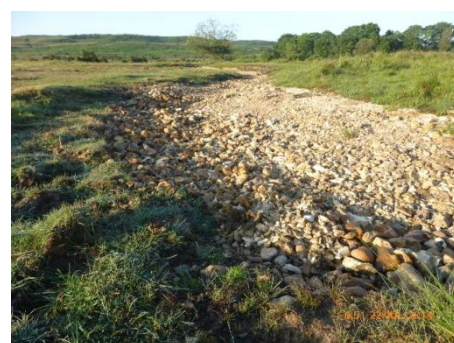
22 July 2014

Why should the rearrangement of the gravel and left bank turned into furrows, work any better when similar flood-flows occur ?

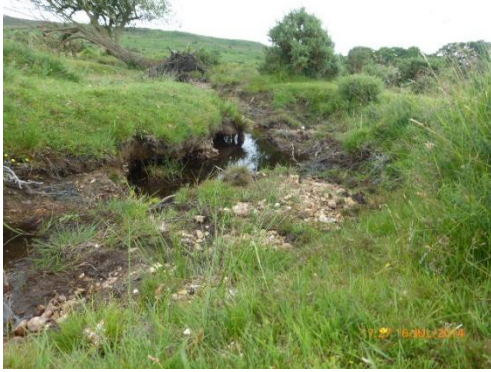
16 July 2014 - Looking downstream towards fallen willow - 2011 heather bales, gravel and clay showing significant erosion and deposition from flood-flows. Was the reintroduction of a meander here unsuited to the stream dynamics making materials unstable ?

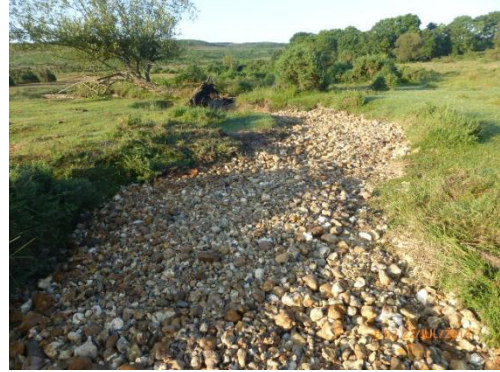
22 July 2014 - New partial infill of heather bales, hoggins, and gravel, similar to 2011 channel.

Why should this react any differently if the channel is not in sympathy with likely flood-flows ?

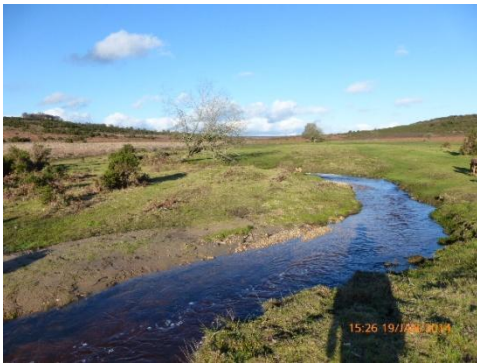
19 January 2014 - same location as photo below, looking upstream towards fallen willow - channel appears stable and shallow.

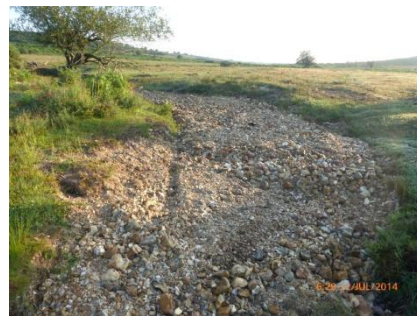
22 July 2014 - The same reach.

Significant infill and widening of the channel, with gravel over-spilling on previously well defined banks. Why was this necessary when the 16 July photo indicates a shallow , stable reach ?

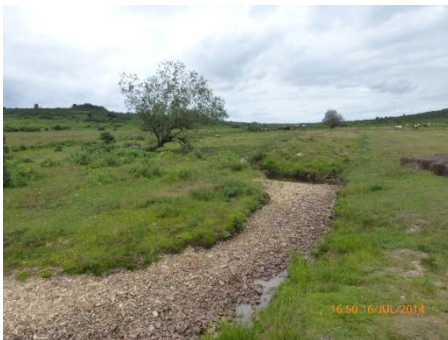
16 July 2014 - Looking upstream towards fallen willow, before the current works. Channel appears stable and shallow.

What was wrong with this ?

Note: the pools under the fallen willow (upstream) have not been infilled, as yet.

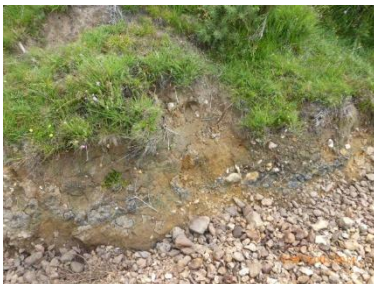
16 July 2014 - clay bank exposed

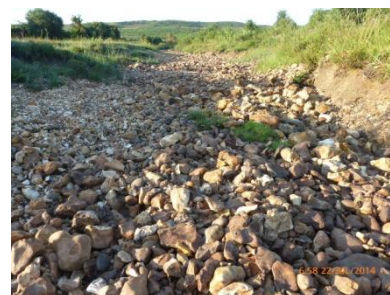
22 July 2014 - large stones "dumped" rather than filled to bank edges. Why ?

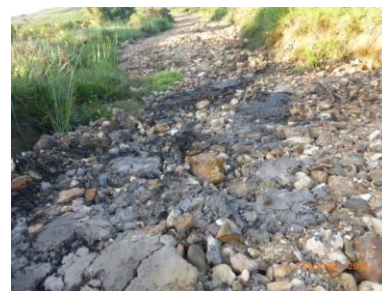
22 July 2014 - Clay "dressing" left on top of gravel.....

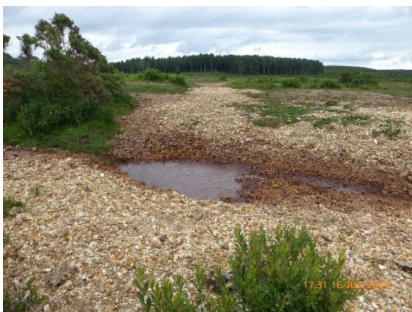
16 July 2014 - looking towards Pitts Wood from the confluence of the two sections with deposits of gravel from the original 2011 works.

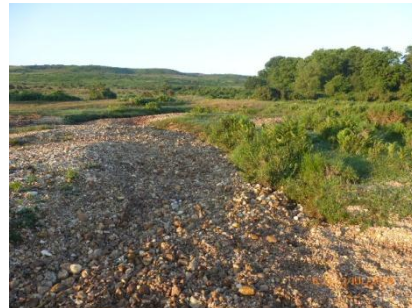
22 July 2014 - at confluence, looking towards Hampton Ridge and Newgrounds. Now infilled with gravel. Unclear if hoggin and clay underneath.....

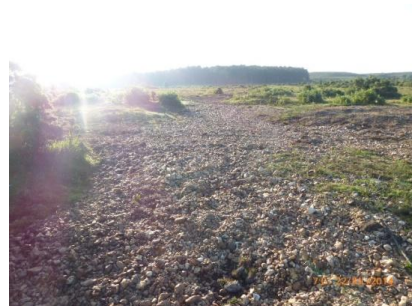
22 July 2014 - looking towards Pitts Wood from confluence, with levelled infill of gravel etc.

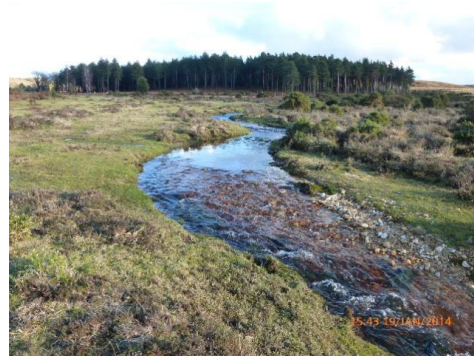
dissipated across the floodplain does not take account of the tremendous forces observed at peak flow, which will utilise the water's power to scour out the weakness in the construction. The photograph from January 2014 below, amply illustrates that the stream at that time looked benign, shallow, with a flat pebbly bed much as may have been the objective of the current works. The water had other ideas.....

Why would such a channel need to be refilled only 6 months later ? Overtopping did not restrict the scouring (see the FC justification for the July 2014 infilling at para 14 above.....)
