**Pondhead
Wetland Restoration
Planning Application**

**Drawing 003: Proposed Site
Plan**

Flooding in the Pondhead / Matley area

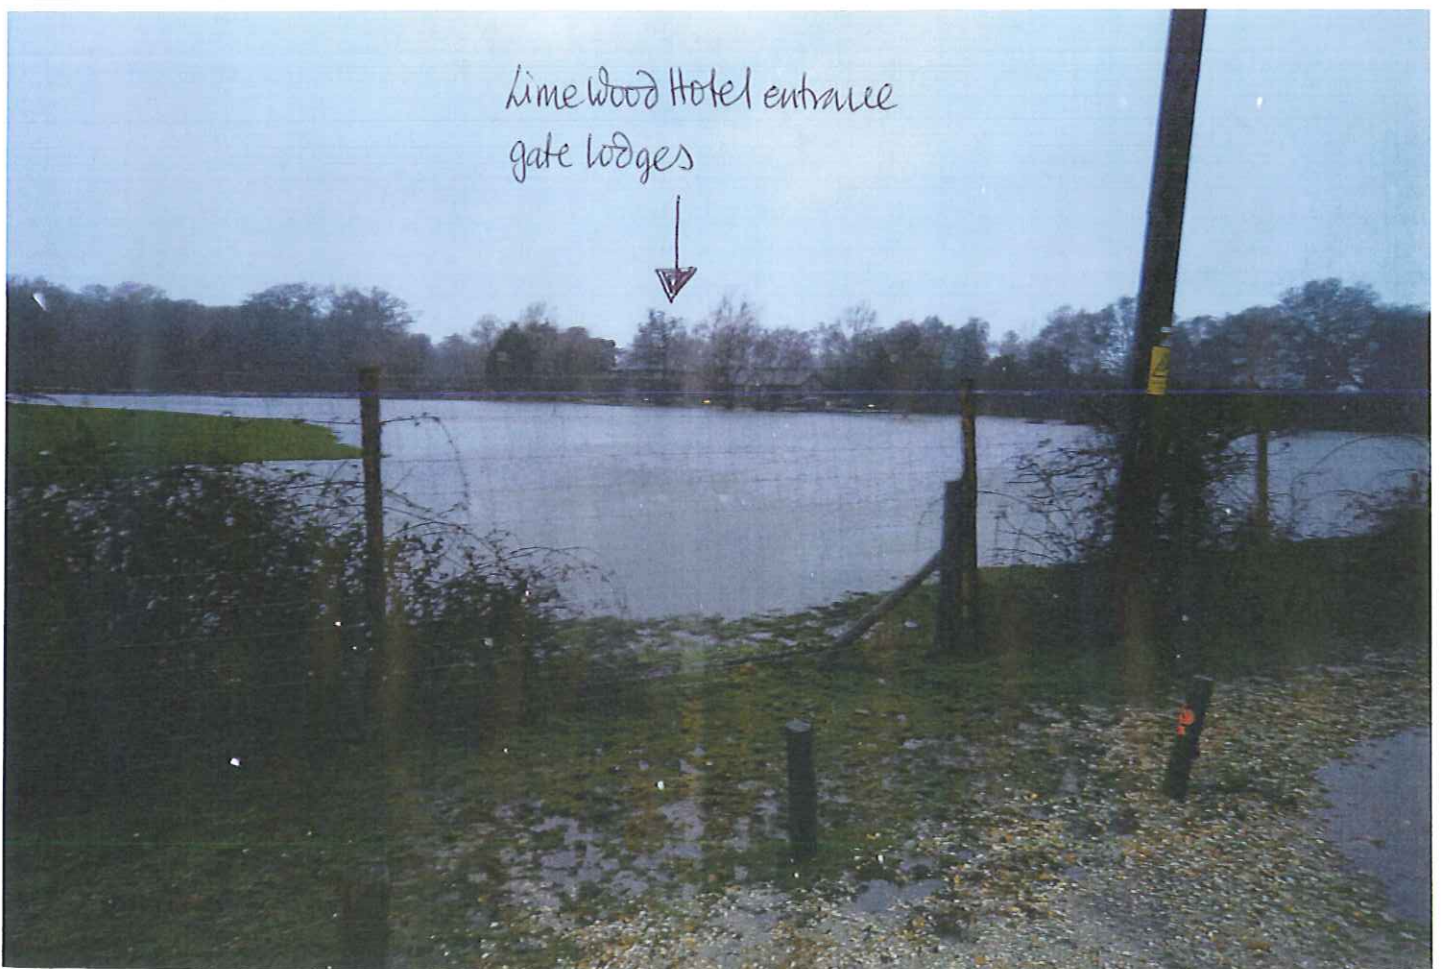
Photo: Winter 2013/2014

The below photo taken in Winter 2013/2014 is looking north west from the Pondhead Farm access track towards the entrance gate lodges at Lime Wood Hotel.

This "lake" was created in 2013/2014 after a sustained period of heavy rain, however, things are now worse since the highway drainage works on Gosport Lane have improved the efficiency of flow from Lyndhurst to the Pondhead / Matley area.

The bridges at Lime Wood and Pondhead Farm act as bottlenecks for the huge volumes of water. The lower bridge (where the "new link" is proposed and the lady was trapped in the mud) now also cannot cope with the increased water volumes. The water catchment area has of course stayed the same, the efficiency of new the drains means that the water arrives much more quickly.

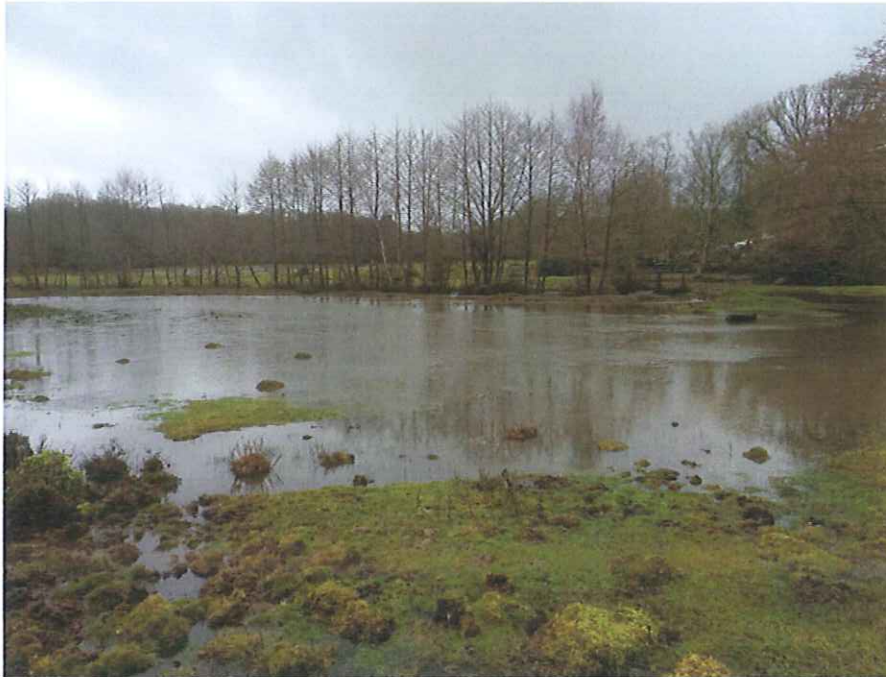
27 January 2016

Flooding after one day of heavy rain occurred here for the first time on 03 and 27 January 2016.

It is the location of the proposed “new link” looking west towards Pondhead Farm (Park Dale Cottage is white in the background). The main flow from Lyndhurst runs along the line of trees (from right to left). The bridge over that flow is to the right of the photo.

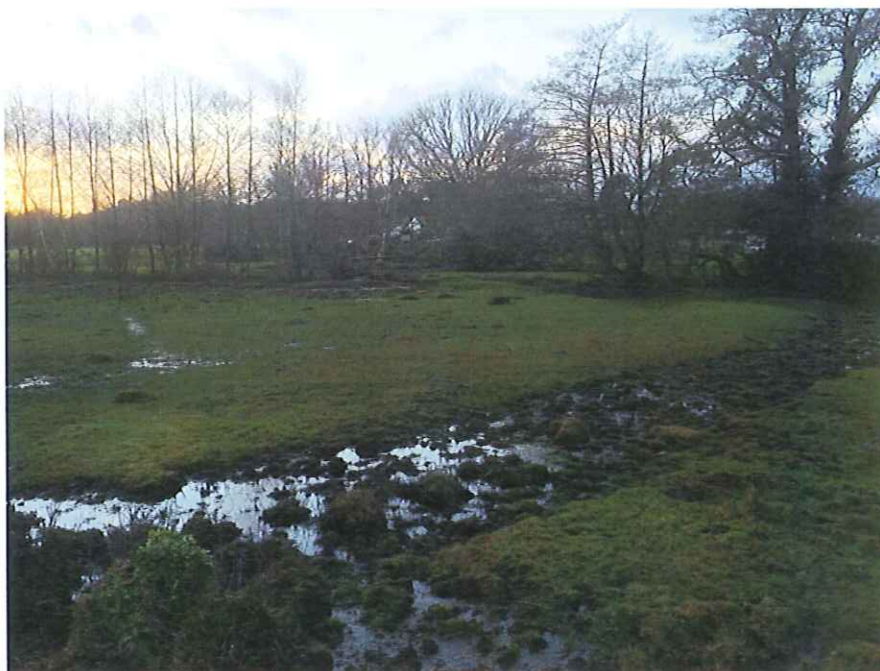
28 January 2016 – Flood water subsided the next day, but left an already wet area dangerously boggy. The area in the foreground is where the lady was trapped in the mud on 04 March 2016.

The lady became trapped in an area adjacent to the location of the proposed "new link" between the "western" and "eastern" side drains.

This area flooded this year for the first time in living memory since the Gosport Lane improvements were completed last year.

The application intends to make this area even wetter. It is already dangerous to pedestrians and stock alike.
