**Pondhead
Wetland Restoration
Planning Application**

**Drawing 003: Proposed Site
Plan**

Flooding in the Pondhead / Matley area

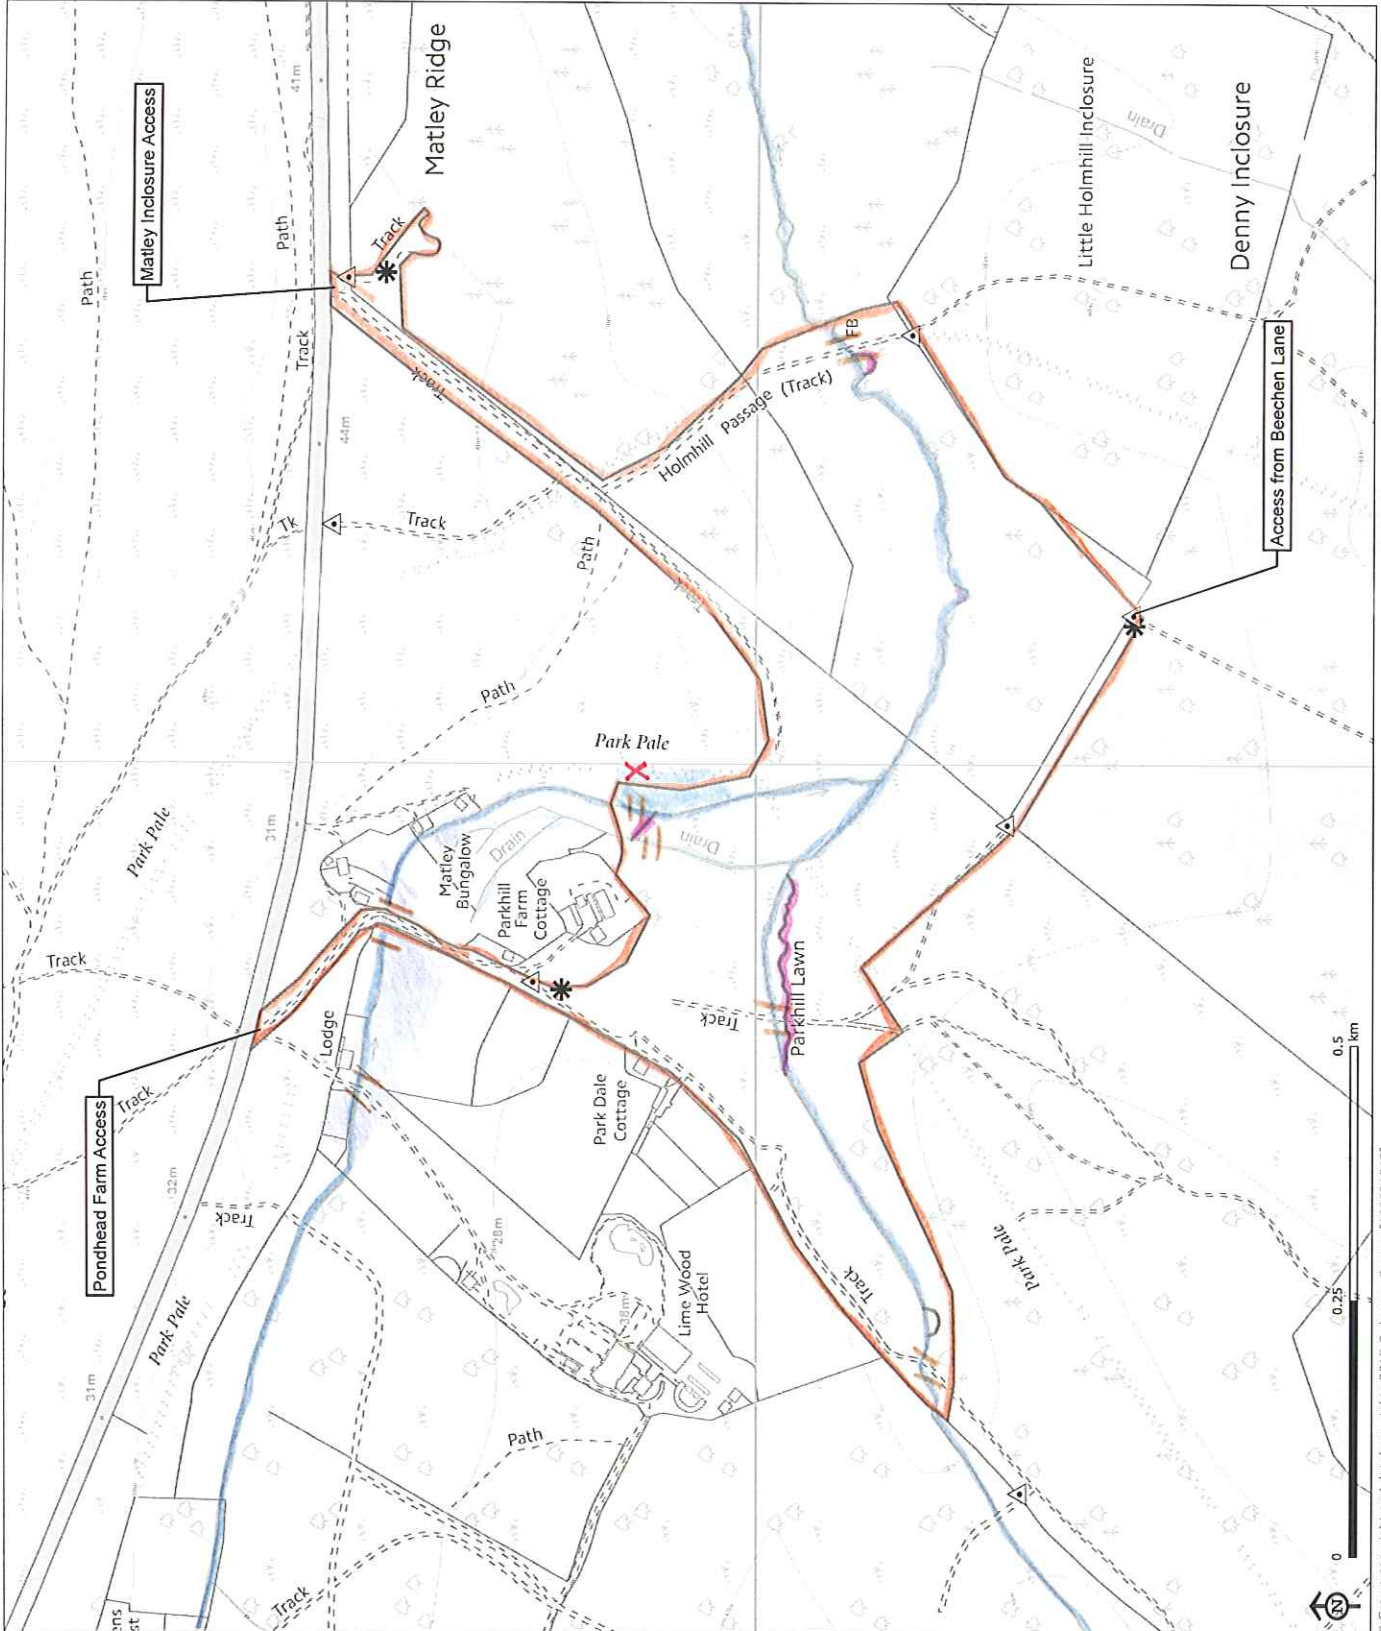
Pre-existing
flooding

(Lime wood +
Borehead farm bridges)

New winter 2016
flood area by new
mill!

Location where
lady trapped in
mud to waist.

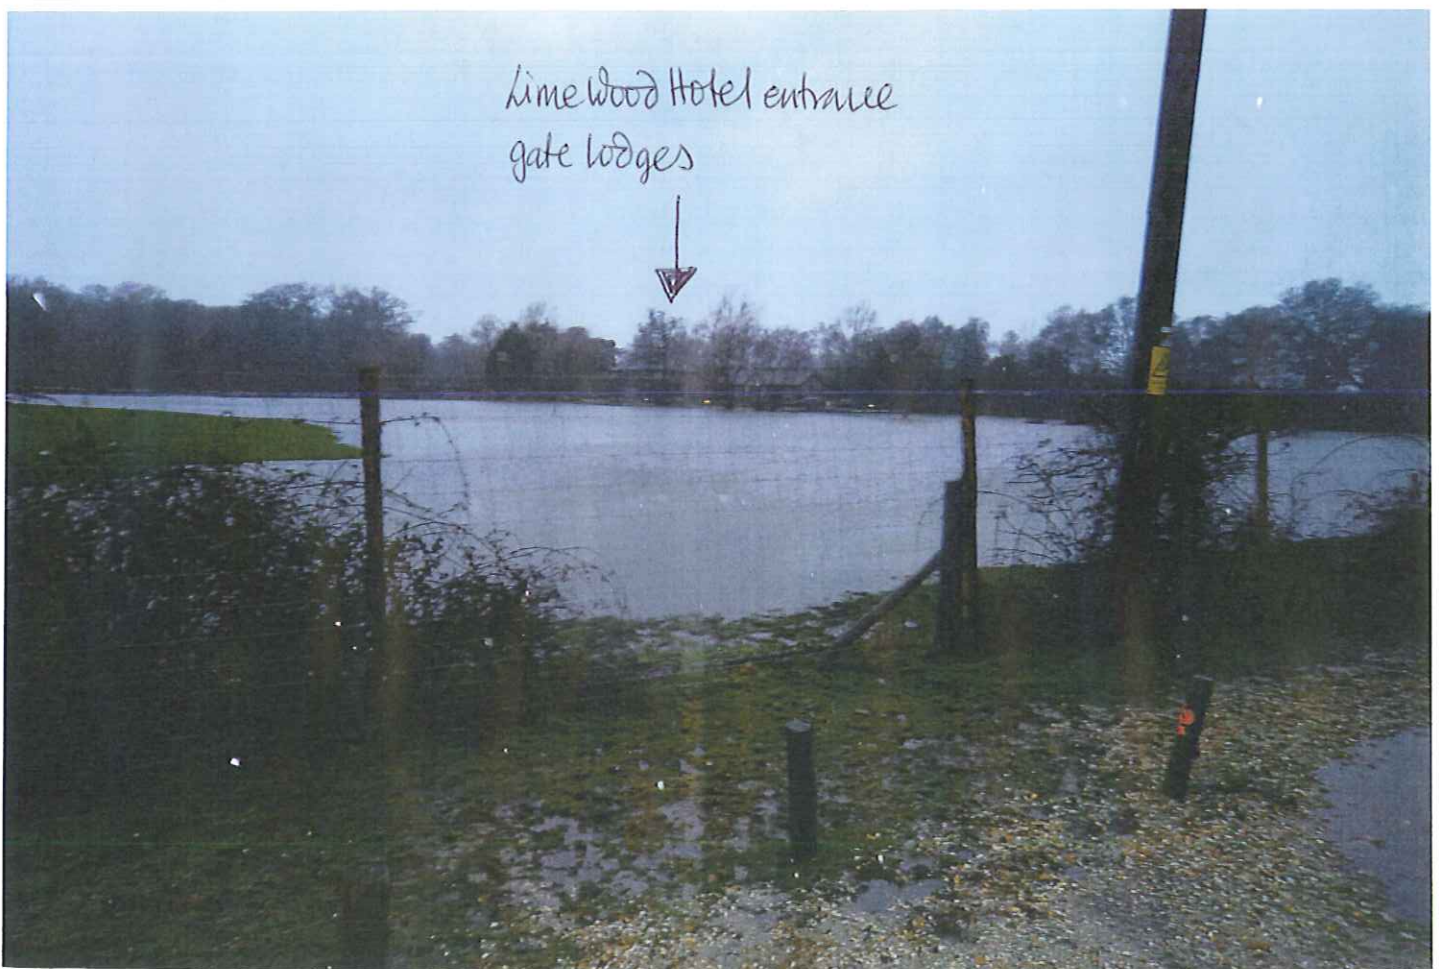
Photo: Winter 2013/2014

The below photo taken in Winter 2013/2014 is looking north west from the Pondhead Farm access track towards the entrance gate lodges at Lime Wood Hotel.

This "lake" was created in 2013/2014 after a sustained period of heavy rain, however, things are now worse since the highway drainage works on Gosport Lane have improved the efficiency of flow from Lyndhurst to the Pondhead / Matley area.

The bridges at Lime Wood and Pondhead Farm act as bottlenecks for the huge volumes of water. The lower bridge (where the "new link" is proposed and the lady was trapped in the mud) now also cannot cope with the increased water volumes. The water catchment area has of course stayed the same, the efficiency of new the drains means that the water arrives much more quickly.

The Forestry Commission's proposal to reduce overall capacity with the "new link" and further slow the water just 100m downstream, is likely to made a bad situation worse.

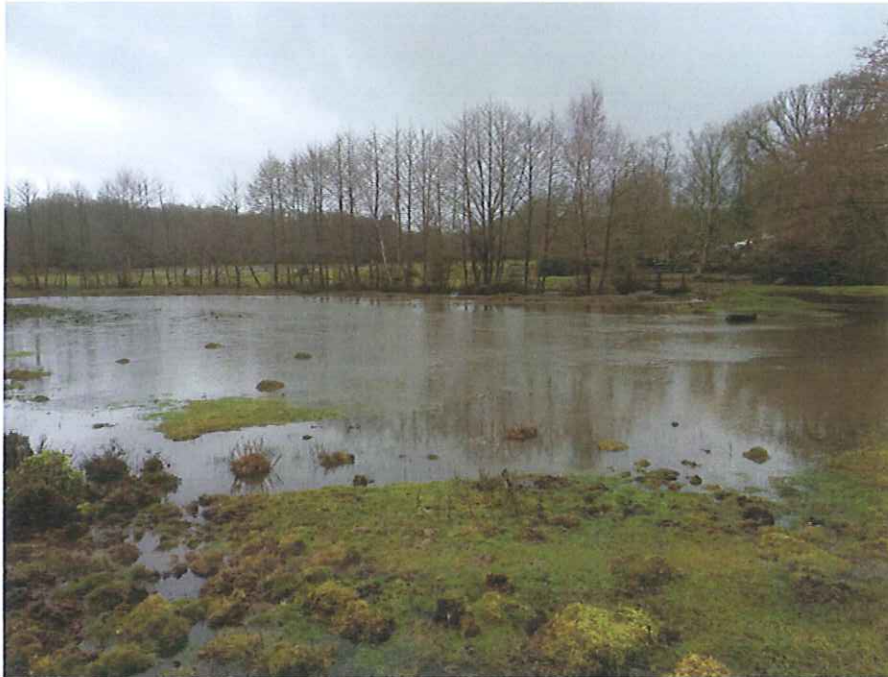
27 January 2016

Flooding after one day of heavy rain occurred here for the first time on 03 and 27 January 2016.

It is the location of the proposed “new link” looking west towards Pondhead Farm (Park Dale Cottage is white in the background). The main flow from Lyndhurst runs along the line of trees (from right to left). The bridge over that flow is to the right of the photo.

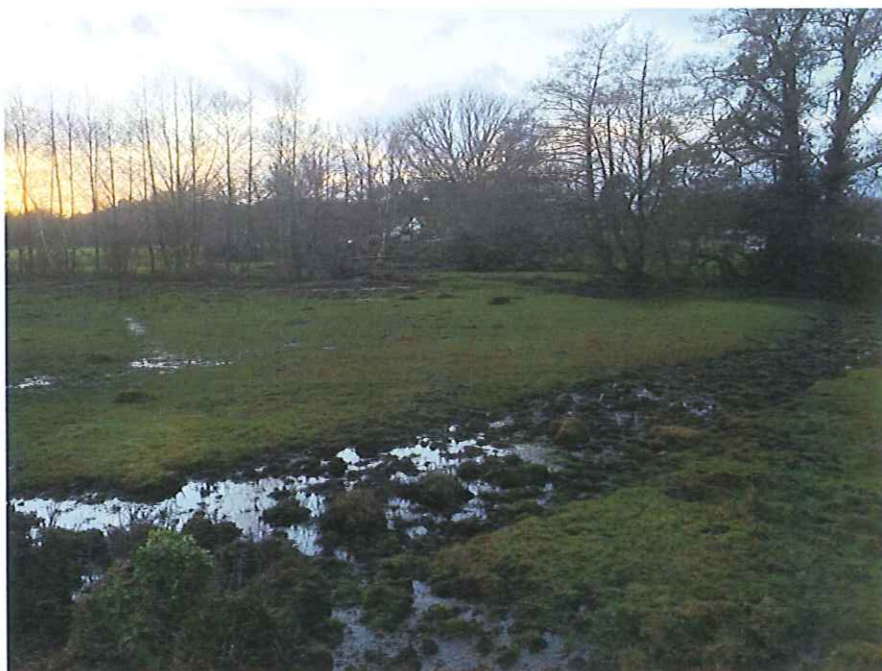
28 January 2016 – Flood water subsided the next day, but left an already wet area dangerously boggy. The area in the foreground is where the lady was trapped in the mud on 04 March 2016.

The lady became trapped in an area adjacent to the location of the proposed "new link" between the "western" and "eastern" side drains.

This area flooded this year for the first time in living memory since the Gosport Lane improvements were completed last year.

The application intends to make this area even wetter. It is already dangerous to pedestrians and stock alike.

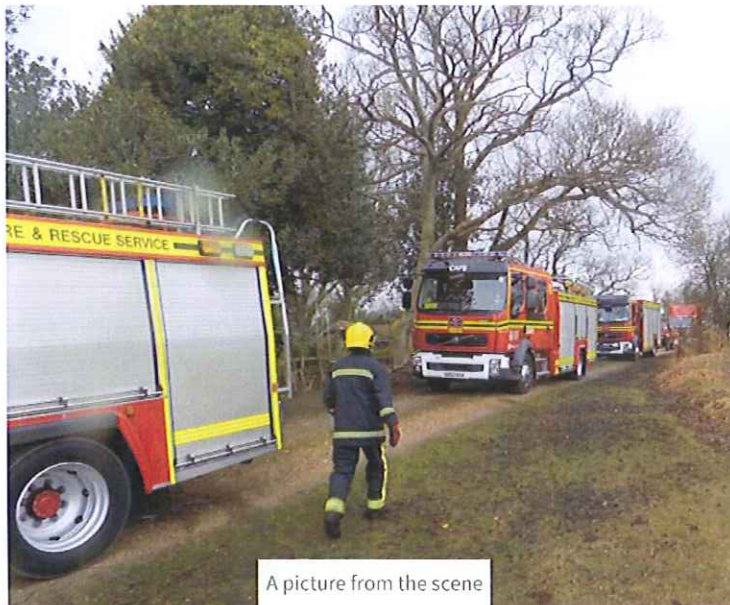
A picture from the scene

A walker became trapped waist-deep in mud in Lyndhurst

HAMPSHIRE firefighters have gone to the aid of a walker trapped up to her waist in mud.

Crews from Brockenhurst, Hardley and **Redbridge** were called to a car park at Matley Wood, near **Lyndhurst**.
